A REMARKABLE BRIDGE ACCIDENT.

REBUILDING OF THE KINNICKINNIC RIVER SWING BRIDGE ON THE CHICAGO & NORTHWESTERN RAILWAY, AT MILWAUKEE, WIS.

BY FRANCIS H. BAINBRIDGE.

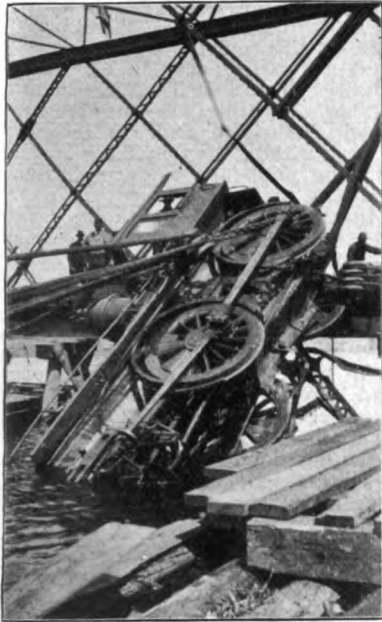
FIG. 1. BRIDGE ACCIDENT, C. & N. W. RY.

A few months ago a "double-header" freight train and a passenger train met in a head-end collision on this structure, with the result that the second engine of the freight train was projected through the side of the bridge. The resultant damage to the truss and the position of the wrecked engine are shown in the accompanying engravings, made from photographs taken very shortly after the accident. The freight train seen in Fig. 2 was the one in collision, and although there were a sufficient number of web members destroyed to leave one floor beam only partly supported, and three entirely unsupported except by the bottom chord, yet the freight train was pulled across the span without causing any undue distortion of the truss.

When the length of this span (115 feet) is taken into consideration, I think that the result of this accident goes far to support the assertion that this type of through truss bridge, between the limits of 100 and 130 feet, is superior to any kind of an articulated structure or to a riveted Pony truss span. A

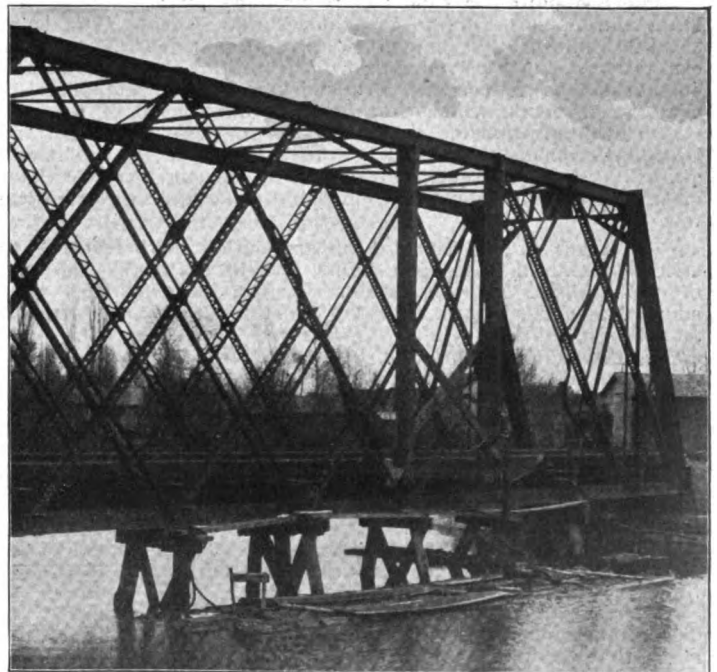
FIG. 2. THE BRIDGE JUST AFTER THE ACCIDENT.

When the writer visited the bridge shortly after the accident, a careful examination of the structure showed it to be still in perfect line, with no perceptible sagging of the damaged truss. Before traffic was resumed temporary bents were put

under the unsupported floor beams and two posts were placed between the top and bottom chords, as shown in Fig. 4.

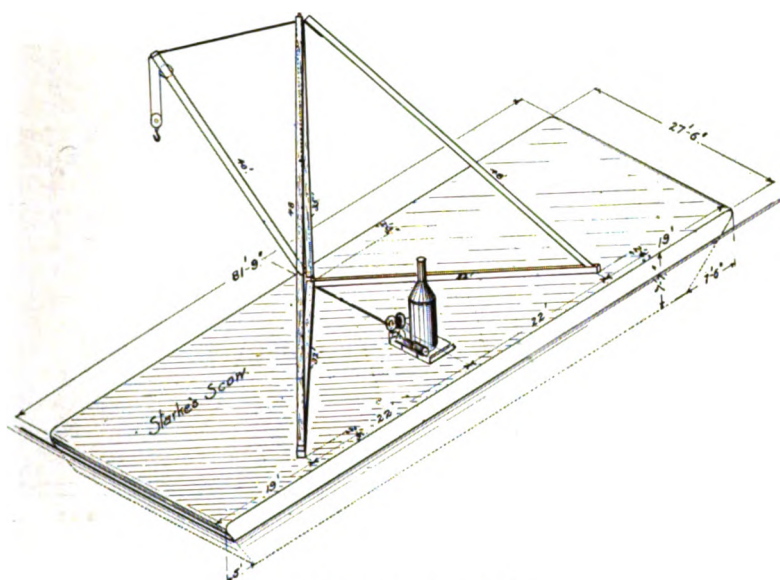
Fig. 8.—Abutment Coffer Dam.

Fig. 7 shows an interior view of the center pier coffer dam, and Fig. 8 the abutment coffer dam.

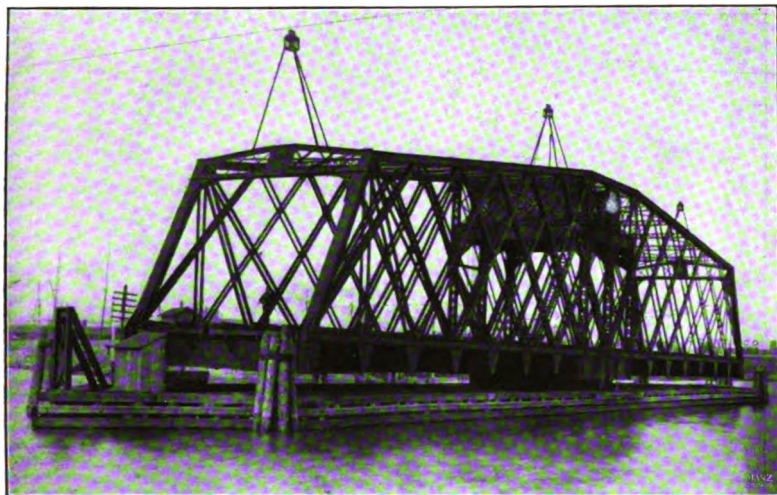
Fig. 11.—Side View of Bridge.

The superstructure is a double track through rivetted lattice span 234 ft. over all. Fig. 11 shows a side view of the completed bridge, and Fig. 12 an end view. Rivetted lattice trusses are standard on the Chicago & Northwestern Ry. for single track fixed spans from 110 ft. to 160 ft., and for double track fixed spans from 110 ft. to 140 ft. Inasmuch as a fixed rivetted lattice span weighs from 15 to 20 per cent. more than a pin-span designed under similar conditions, some substantial reasons should exist for using the former. These are principally that rivetted lattice trusses have withstood the effects of the constantly increasing weight of rolling stock better than pin-bridges have, and that they are less liable than a pin-bridge to be

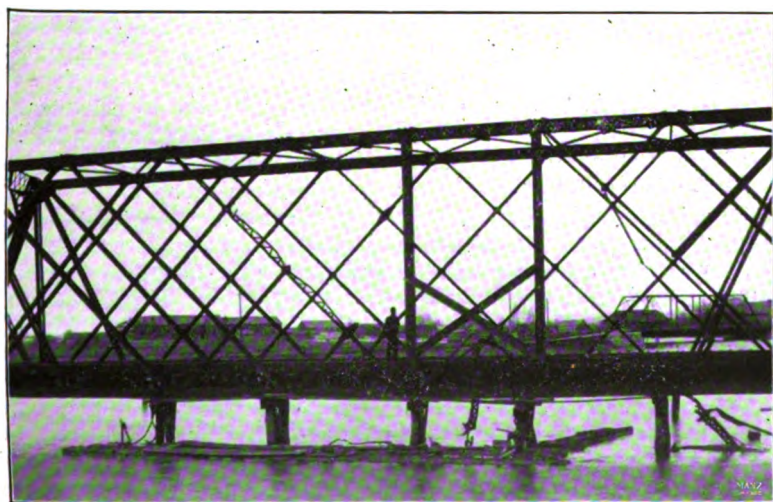
Fig. 13.—Accident to Bridge at Fond du Lac.

wrecked by a derailed train. Fig. 13 shows a rivetted lattice span at
Fond du Lac, Wis., just after a collision had occurred on the bridge
in April, 1898. A freight locomotive left the track and passed com-
pletely through the side of the bridge, as shown in the photograph,
severing the web members at three panel points. Notwithstanding
this the train which the eng 'e had been hauling was successfully
drawn off the bridge and four other trains run over it before any
repairs had been made or supports supplied. Fig. 14 shows a side
view of the same truss after bents had been placed under the un-
supported floorbeams. It clearly shows the extent of the damage
which had taken place. Some years ago Mr. Stowell, at that time
bridge engineer for the state of New York, cited a number of cases
in which end posts in lattice bridges had been completely broken
without wrecking the structure.

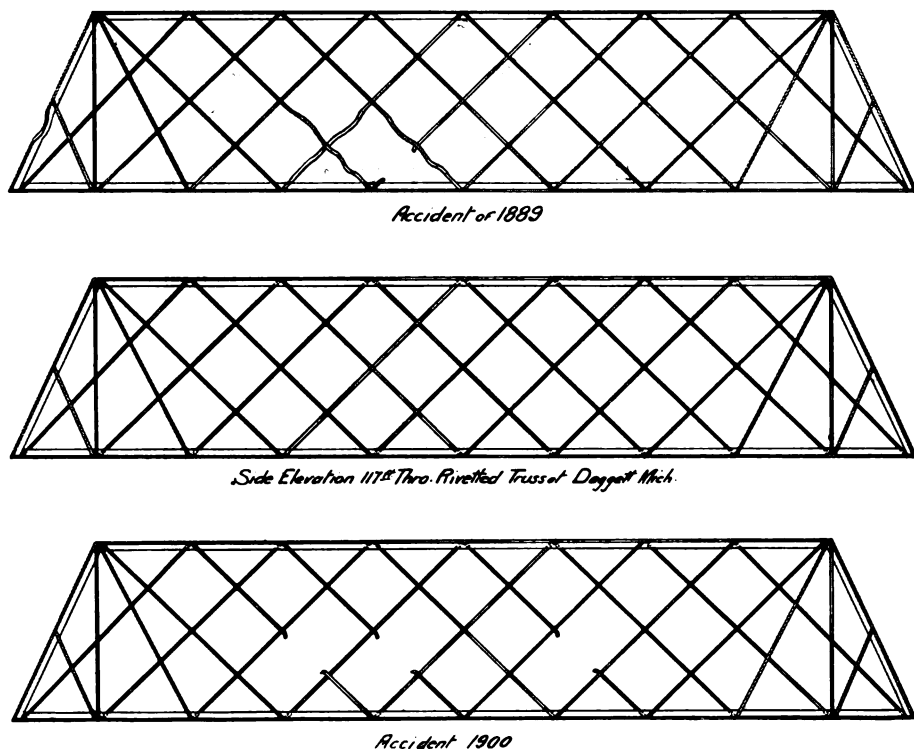
Fig. 15.—Accidents to Bridge at Daggett, Mich.

Fig. 15 shows the effects of two accidents which happened to a riv-
etted lattice span on the Chicago & Northwestern Ry. at Daggett,
Mich., both accidents being caused by logs projecting from a mov-
ing train. In both cases it would appear that a log projecting from
a car struck the end post and caused the entire load of the car to
shift, raking the whole side of one truss.

Accident of 1889

Accident 1900

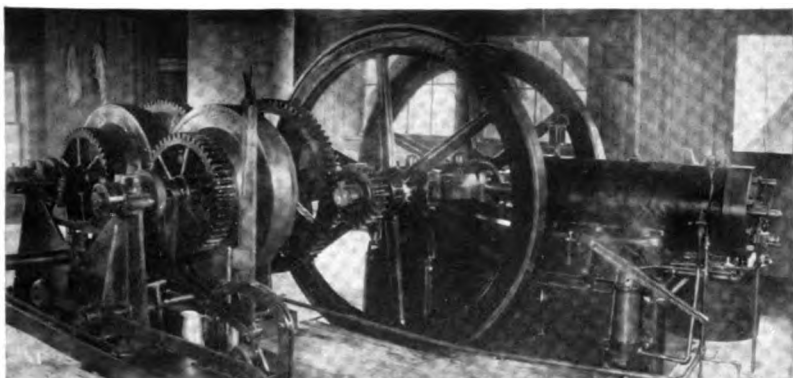
Fig. 18.—Engine and Friction Drums.

Fig. 18 is a photograph of the engine and the two friction drums. The writer has had experience with two bridges operated by gasoline engines, and in both cases the engines have proved convenient, economical and satisfactory. The engines are built commercially principally for continuous service. On swing bridges the service is intermittent and it is essential that the engine should start off at the first trial. The operation of starting is to pour a small quantity of gasoline into a receptacle below the hand air pump. This receptacle is filled with wood fibre, which absorbs the gasoline. Then with half a dozen quick strokes of the air pump air is drawn through the

If the engine-house is attached to the bridge trusses, it must be remembered that the rapid revolution of the fly-wheel causes considerable vibration, and the engine floor and adjacent parts of the truss must be stiff enough to resist it.
