REINFORCED CONCRETE SLAB BRIDGE.

The Minneapolis, St. Paul & Sault Ste. Marie has adopted concrete slab bridges, reinforced by the "mushroom" system, for a number of highway crossing locations. This system of reinforcement, patented by C. A. P. Turner, consulting engineer, Minneapolis, has been in use for sometime in building construction, but has not been widely adopted for railway bridge construction. Two bridges built in the town of Amherst, Wis., are typical of these structures. The details of the Lincoln street bridge are shown in the accompanying illustration.

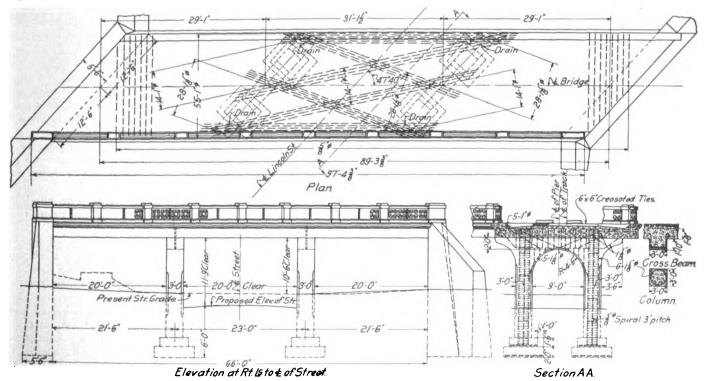
The street is crossed on a skew of 47 deg. and 40 min., the abutments and piers being parallel at an angle with the center line of the street. The piers consist of two reinforced concrete

columns 3 ft. square spaced 12 ft. center to center, connected at the top by a concrete beam. The footings are spread to 7 ft. square and are reinforced in four directions, as shown in the drawing. The columns are reinforced by six 1½-in. round rods set vertically and banded spirally by ½-in. round rods on 3-in. pitch. The columns are 14 ft. 3 in. high from top of footings to bottom of slab, and the corners are chamfered to a depth of 3 in. The transverse beams, which have a minimum depth of 2 ft. below the slab, are arched between columns and are carried out beyond the columns on the curved lines shown in the accompanying cross section. The beams are reinforced in the upper plane by five 1-in. round rods, and in the lower plane by eight 1½-in. round rods bent up for shear reinforcement, and five 1½-in. rods bent down for surface reinforcement over the arch. In

The floor slab is reinforced in four directions, in accordance with the usual "mushroom" design, the rods being crossed over each column in the piers. The reinforcement parallel to the center line of track consists of 1-in. round rods spaced 4 in. center to center, and that perpendicular to the center line of tracks of %-in. rods spaced 12 in. center to center. The diagonal reinforcement connecting alternate pier columns consists of 11%-

in. round rods for the shorter lengths and 1-in. rods spaced 6 in. center to center for the longer lengths. The central span is 31 ft. 1½ in., and the two sidewalk spans are 29 ft. 1 in. Drainage is carried in troughs built in the upper surface of the slab on either side of the ties to outlets over each pier. The clearance over the street level is 11 ft. 9 in., and between railings 16 ft.

Plan and Elevation of Subway Built at Amherst, Wis., for Minneapolis, St. Paul & Sault Ste. Marie, Showing Column and Slab Reinforcement.
